Manhole Inspection Summary

Manhole # S15S__013MH

Inspection ☐ Is Incomplete Rating: **4) Poor**

Location Address: **1050 s dukeland st**

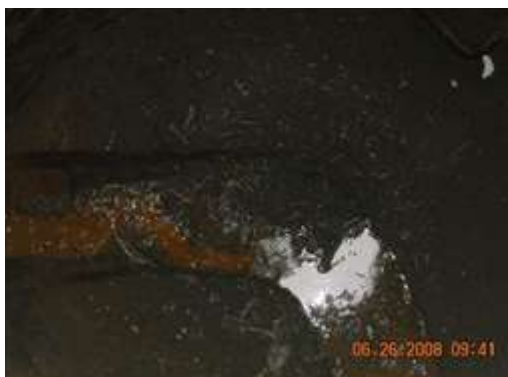
Misc

Condition: ☐ Sound ☐ Cracked ☐ Root Intrusion ☐ Deteriorated ☐ Leaks ☒ **Debris**

debris in channel

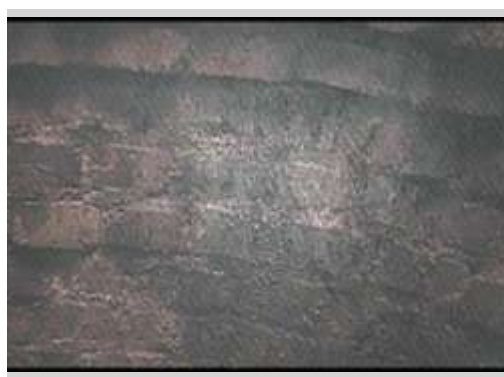
Defect 6

Infiltration: ☐ None ☐ Joint ☐ Cracks ☐ Mortar ☐ Roots ☒ **Wall**

infiltration @ barrel wall

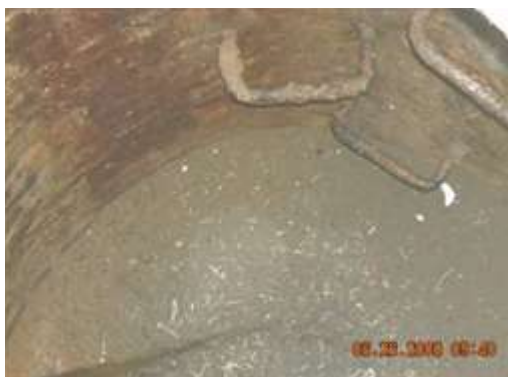
Defect 4

Condition: ☐ Sound ☐ Cracked ☐ Root Intrusion ☐ Deteriorated ☐ Leaks ☒ **Debris**

debris on bench

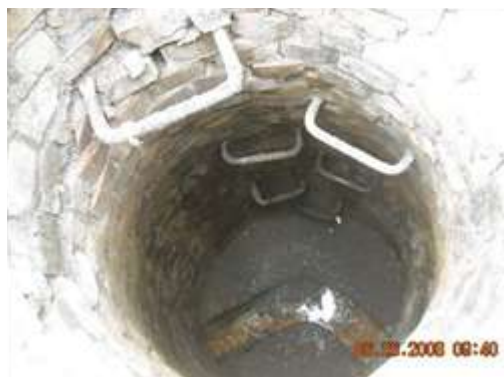
Defect 3

Count: **6** Missing: **0** ☒ **Corroded**

corroded steps

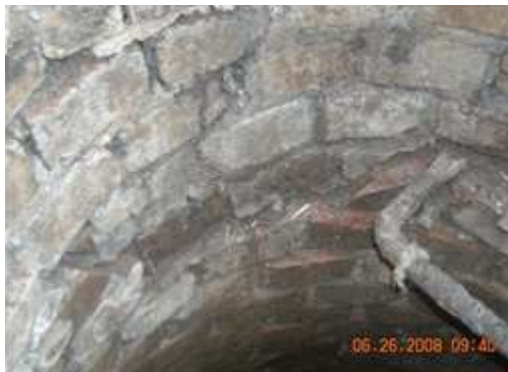
Defect 2

Condition: ☐ Sound ☒ **Cracked** ☐ Root Intrusion ☐ Loose Brick ☒ **Deteriorated**

cracked corbel bricks

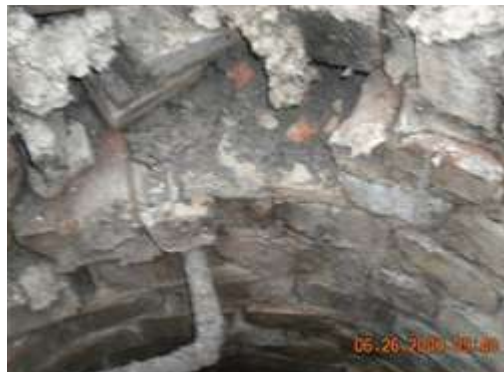
Defect 1

deteriorated corbel bricks

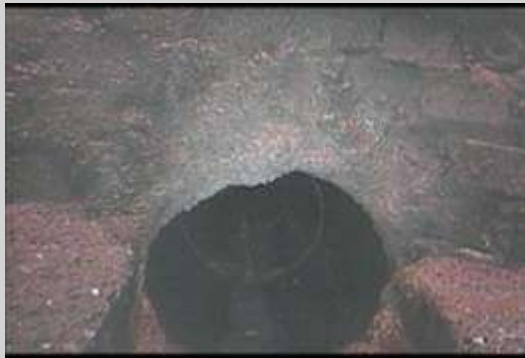
12 O'Clock Outflow

Pipe Height: **12** (in.) Rod and Bar (Angled)
Pipe Material: **Clay** ☐ Pipe Lined
Invert Depth: **11.02** (ft.) Flow Characteristics: **Slow**
Deposits: ☐ None ☒ **Mud** ☒ **Sludge** ☐ Debris ☐ Grease
Silt Depth: **3** (in.) Deposits Extent: **Light**
Infiltration: **None** Pipe Seal Cond: **Sound**

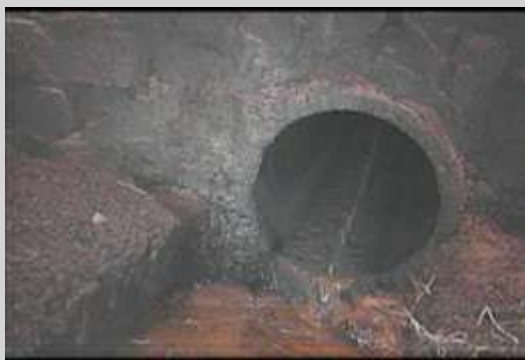
8 O'Clock Inflow

Pipe Height: **8.4** (in.) Rod and Bar (Angled)
Pipe Material: **Clay** ☐ Pipe Lined
Invert Depth: **10.38** (ft.) Flow Characteristics: **Slow**
Deposits: ☐ None ☒ **Mud** ☒ **Sludge** ☐ Debris ☐ Grease
Silt Depth: **1** (in.) Deposits Extent: **Medium**
Infiltration: **None** Pipe Seal Cond: **Sound**
